Architectural Joinery

These pictures were taken at the Norwegian Heritage Museum in Oslo, of buildings transported from various sites and re-erected in the grounds of the museum. They are preserved as they were built. The museum restores and maintains the buildings on the site.

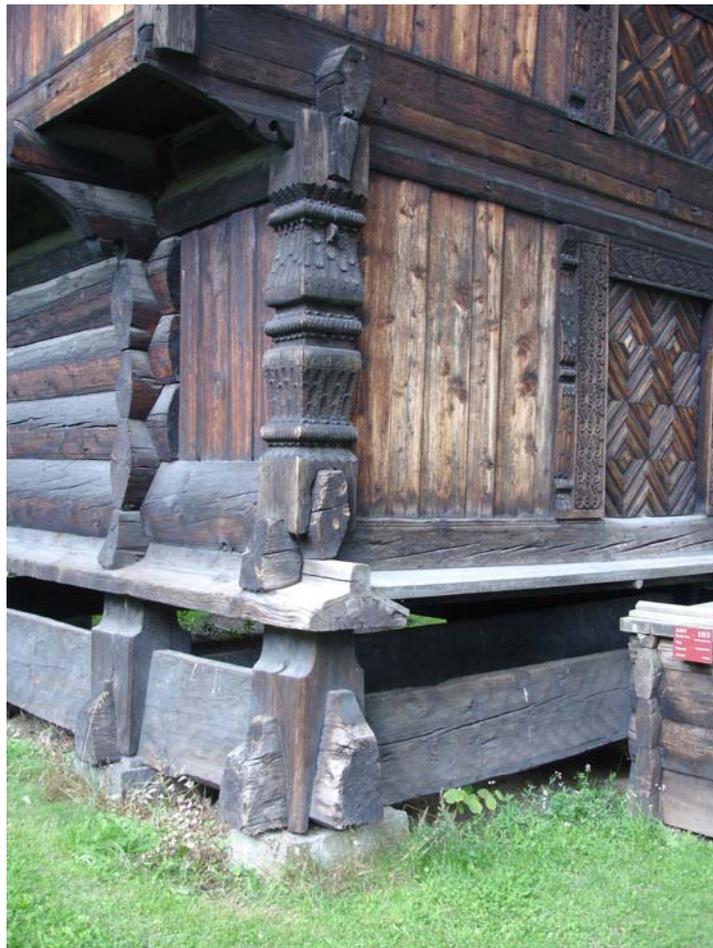
The second picture shows a close up of the corner. You can see that stone footings are used, but then everything above that is made of wood. The base is made from very substantial beams that interlock at the corners with the upright columns. The joints and ends all slope outwards, to shed water and snow. The undercut posts fit into sockets in the beams resting on top of them. The walls are made from beams that are halved and hewed straight with an axe. Each is notched top and bottom, so that it interlocks with beams below and above. Where necessary, wooden pegs were used to fasten the joints together. The corner pillars are carved, as are the door posts.

The horizontal beams making up the walls interlock. Even though they may have been closely fitted at the time, they may not have been fully dry, so the gaps were probably filled with dried mud mixed with straw, to keep the weather out.

Usually, the wood used for building such as the walls was not seasoned. So allowances had to be made for shrinkage. This could be a problem if vertical timber columns are used in addition to the horizontal members making up the wall, so this needs to be allowed for in the design. (As wood dries, it shrinks more across the grain than lengthways, so the cross pieces can be expected to shrink more the vertical column.)

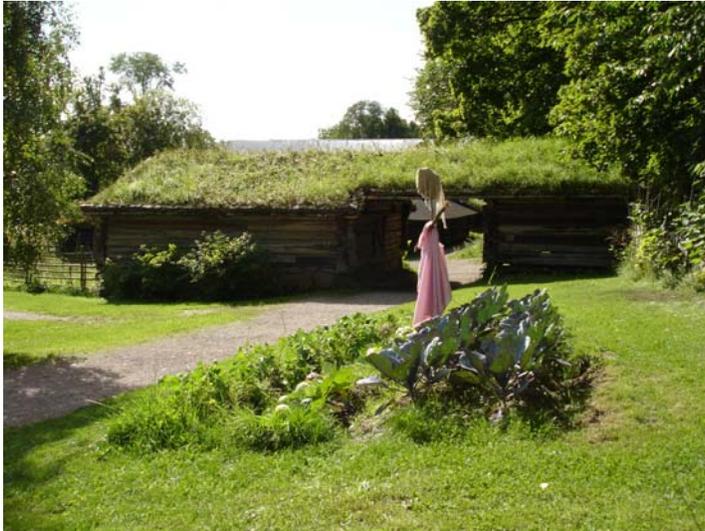
The roof on the building in the picture below is made of turf, which is an effective insulator. In the foreground is a vegetable garden with a scarecrow.

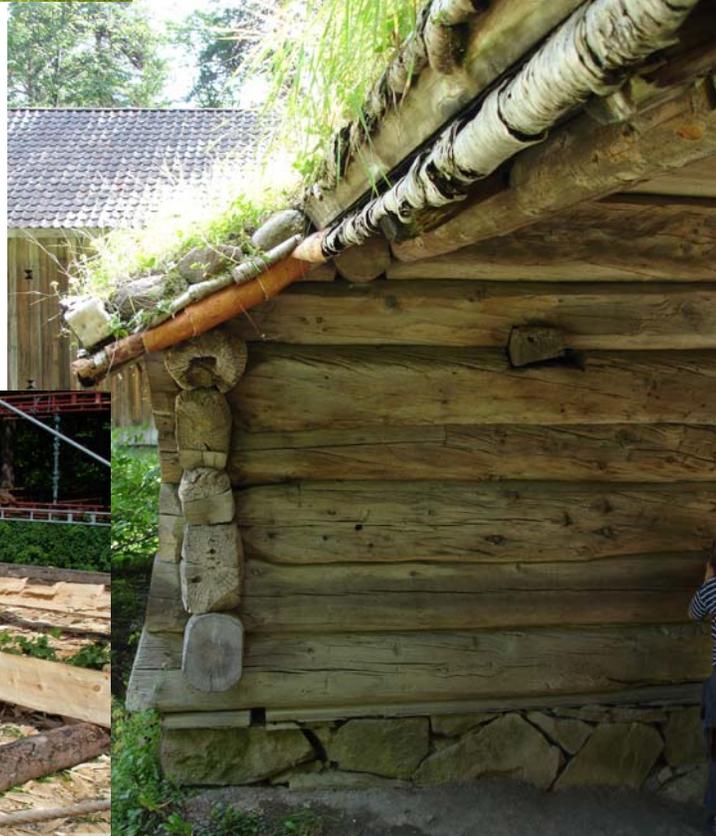
The next picture shows the detail of the roof at the passage between the parts of the building. Under the turf, you can see two layers of birch bark that are used for water proofing. The silver birch (*Betula alba* or *Betula pendula*) grows widely in Norwegian forests. The bark was probably stripped off while the tree was green, so that it was still flexible and could be flattened without cracking.

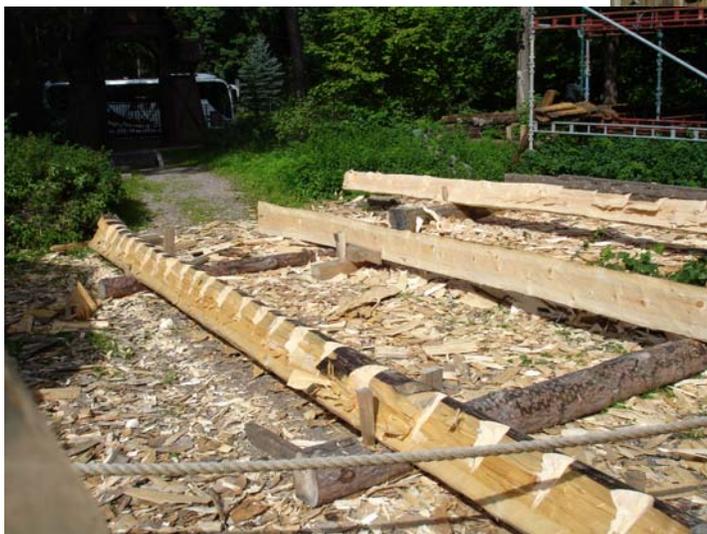
The last picture shows the process of hewing beams from solid pine boles. The beam in the front has notches cut to a uniform depth. These are then cut away using a side axe. The beam at the back shows this in progress. The one in the middle is completed. These beams are intended for use in restoring a building surrounded by scaffolding in the background. The beams used for the walls of the turf-roofed building were probably made in this way too.
