Cheap No-name planes – Issues?

© Trevor Pope (tpope AT iafrica.com) – December 2016

This example is branded MTS #3 and is equivalent in size to the Stanley #3, albeit slightly larger. It is imported into South Africa by Matus and is sold widely in hardware shops - #3, #4 and #5 models are available from about R350- upwards.

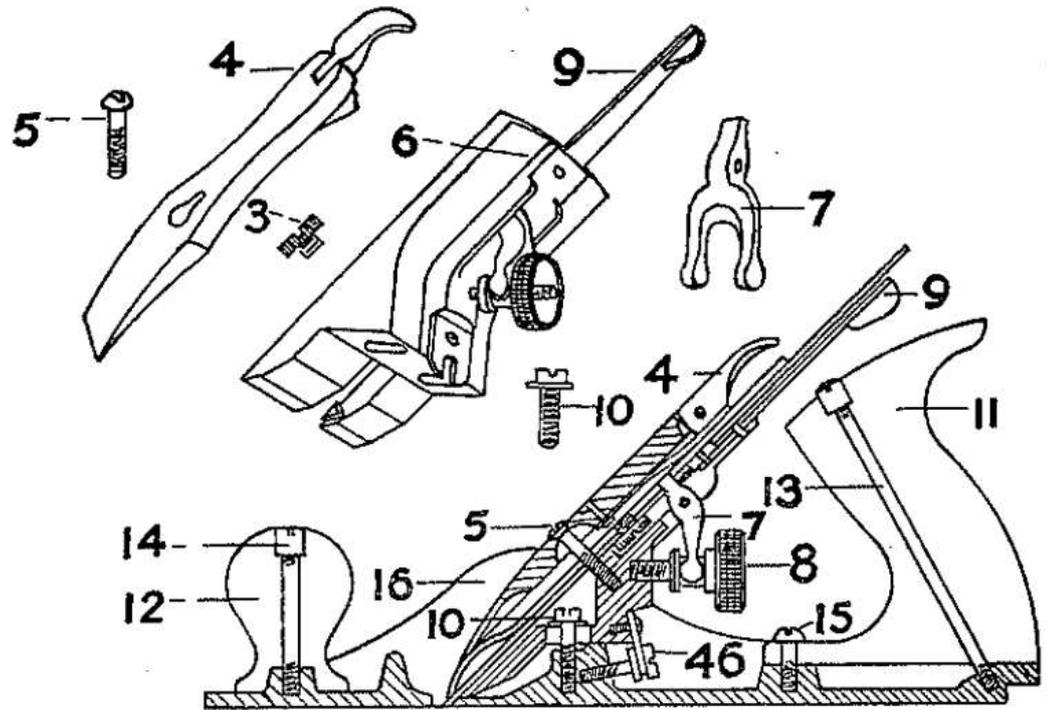
Fig. 22.—Parts of Record Planes.

I have included this diagram of the cross section of the Record #3 plane for reference, in case you are unfamiliar with the technical names for the parts of a hand plane. It comes from an old Record book on their planes.

3—Cap Screw. 4—Lever Cap. 5—Lever Cap Screw. 6—Frog, complete. 7—"Y" Adjusting Lever. 8—Adjusting Nut. 9—Lateral Adjusting Lever. 10—Frog Screw. 11—Plane Handle. 12—Plane Knob. 13—Handle Bolt and Nut. 14—Knob Bolt and Nut. 15—Handle Toe Screw. 16—Plane Body. 46—Frog Adjusting Screw.

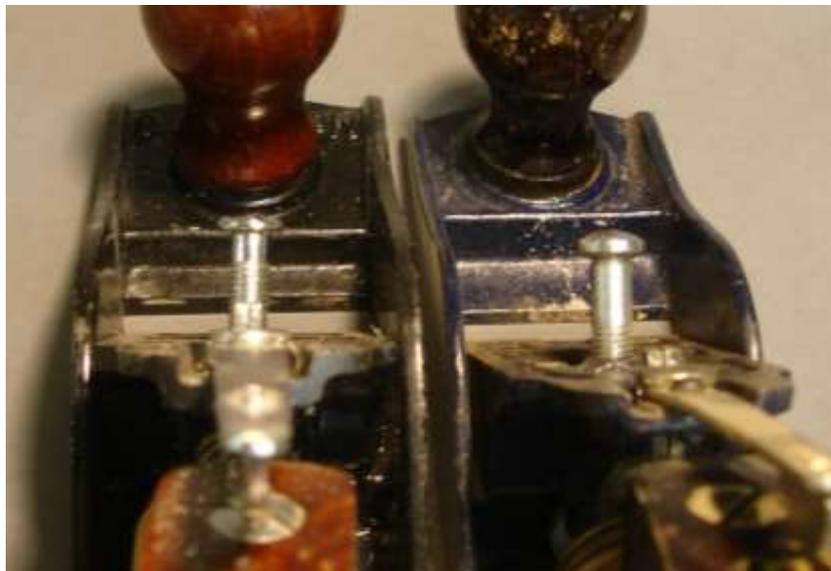
- The MTS' lateral adjustment lever (9) protrudes too high above the frog, so it fouls the slot in the bottom the blade. The mounting point protrudes by about 1mm, so even bending the lever downwards, will not correct the restricted movement - the lever cannot perform its lateral adjustment function over the required range. Fortunately, with the wide mouth, there is enough play to make the

necessary lateral adjustment, but I don't think this was intentional.

- The lever cap cannot be lengthened,
- the blade cannot be widened,
- and the shape of the lever cap hold-down screw can't be corrected without replacing them,
- and the lateral adjustment lever can't be lowered.

- Reshaped the cam on the lever cap to a better shape. To do this, Ken drove out the roll pin that the lever cap cam pivots on and then filed the shape of the cam. He then replaced the roll pin.
- Filed the key-hole slot in the lever cap to extend it to lower the bottom point of contact
- Lowered the lateral adjustment lever to flush with the top surface of the frog. He did this by drilling out the rivet to remove the lever, filing down the bearing surface and then riveting the lever back onto the lever cap.
- Adjusted the frog to properly line up with the throat and the sole.

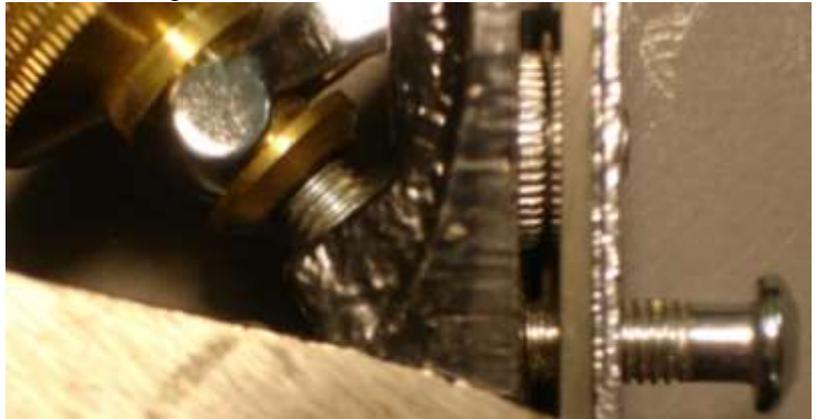
- The depth adjustment wheel (8) on the back of the frog is brass, but the tolerance of the thread on the stud is such there is excessive play, showing up as a disconcerting wobble. This also manifests itself as extra backlash and uncertainty in the cutting depth adjustment setting.

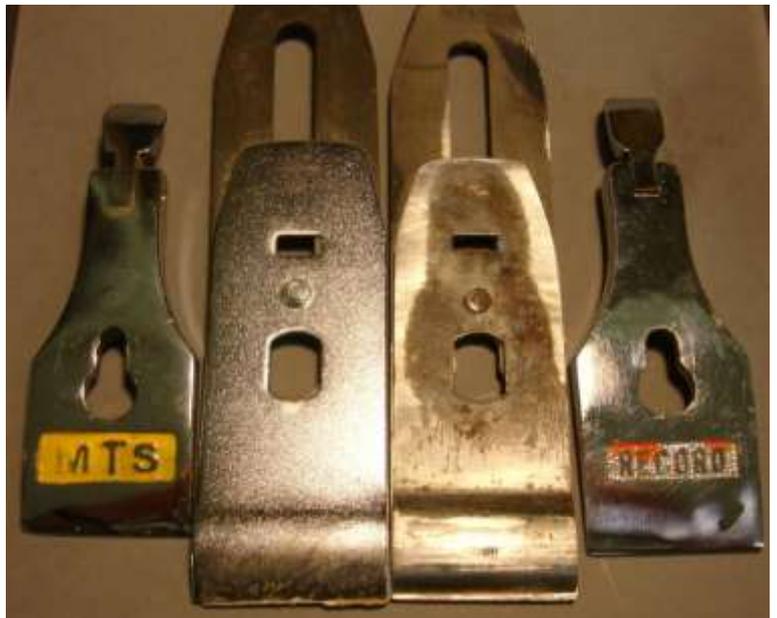
- The most significant flaw appeared when the lever-cap (4) was inspected. The lever-cap is too short, so at the bottom end, it presses down on the upper part of the cap iron. The photo shows the MTS cap iron and blade on the left, next to the genuine Record #3 items on the right. You can clearly see how much shorter the MTS lever cap is compared to the record. You can also see that it contacts the cap iron too high up.

The combination of these latter three flaws means that when the plane is used, vibrations from the cutting forces can cause the lever cap to move backwards and pop off, as Steven has experienced.
