Wooden Panel Raising Plane

©Trevor Pope (tpope AT iafrica.com) - Feb 2008

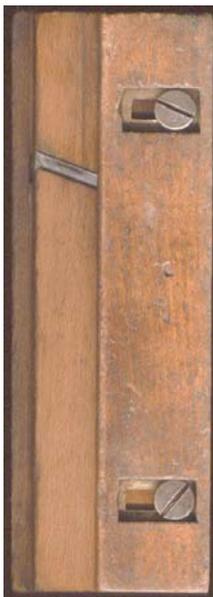
The next task was to make a new wedge. This wasn't easy, as there was no part to copy, so the new one had to be laboriously fitted into the body. Due to the skewed blade design, there were no right angles either. I looked at the wedge design of a wooden jack plane that I had and copied that. The existing parts were made from beech, so I also used beech. It doesn't match the colour of the old parts, but it is a new part. Maybe in 50 years time it will. The picture on the right shows the replacement wedge.

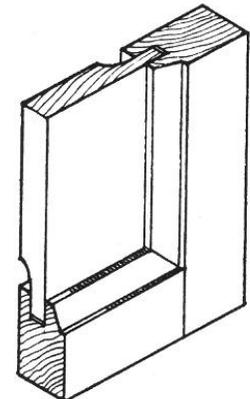
So what is a fielded panel? In medieval times, much furniture was made from solid boards, which created a problem for any sort of six sided box as inevitably two panels would have different grain orientations, with differing rates of expansion. Cupboard doors would stick and sides would split with the changing seasons. The innovation that cured this was the frame and panel method of construction, still used today. The frame consisted of two rails (the vertical parts) and two styles (the horizontal parts), joined together using mortises and tenons in better work. The inside edges of the frame had a groove cut, using a fillister plane, and a panel was located in the groove, thereby filling in the middle. The diagrams show a section with a

rail, a style and part of a panel. The diagram on the left shows a simple bevel. A more complex bevel with a compound profile, such as this plane can make, is shown in the diagram on the right. The panel is made a slightly loose fit widthwise, across the grain, to account for expansion and contraction differences between the panel and the frame. Usually, the panel would be a similar thickness to the frame. So to fit into the groove, it would be thinned down around the edges. This thinning is called fielding, and fielding plane like the one above would be used for this.

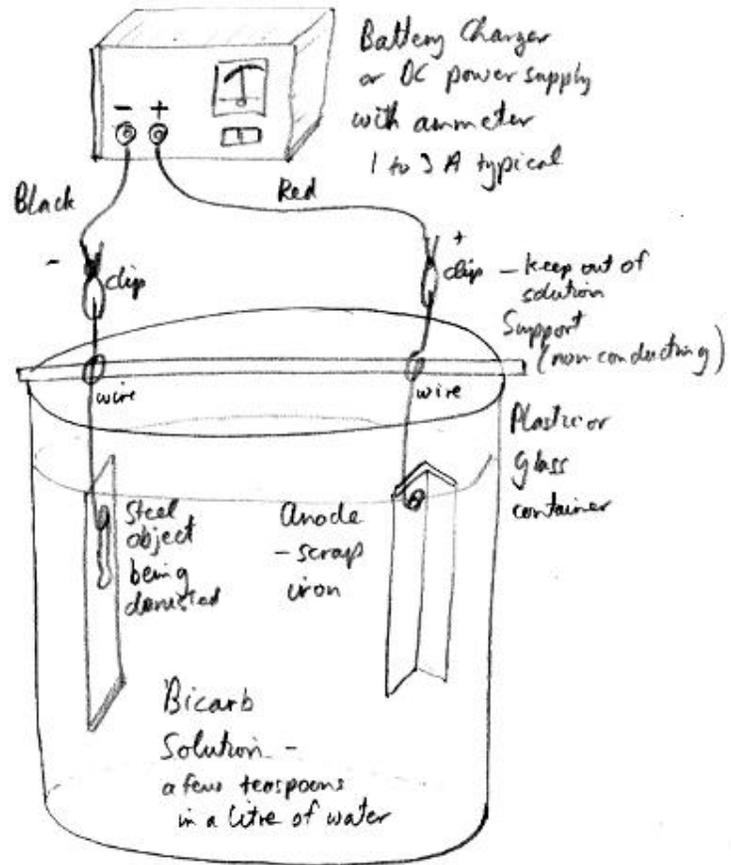
Derusting

The setup shown in the diagram was used for derusting the metal parts of the plane:

The benefit of electrolysis over other derusting methods is it removes only the rust and no sound iron. This is particularly important for valuable antiques, as the minimum harm is done. This is better than more aggressive methods of rust removable such as chemical removers, such as phosphoric acid, or wire wheels, sandblasting and sandpaper which can damage a piece further. The container must be non-conductive, so it is not involved in the process. The solution before and after is harmless, so safe disposal is not a problem. When derusting more exotic steels, such as those containing vanadium, I would be more cautious with the solution, as several constituents in high performance steels are known to be toxic.
