## False Economy

©Trevor Pope (tpope AT iafrica.com) – Apr 2013

The example of false economy that I have in mind is the bearing fitted to the live centre supplied with my Jet 1014 Mini lathe (2004 vintage). The Jet live centre is a cheap and simple design that is also versatile.

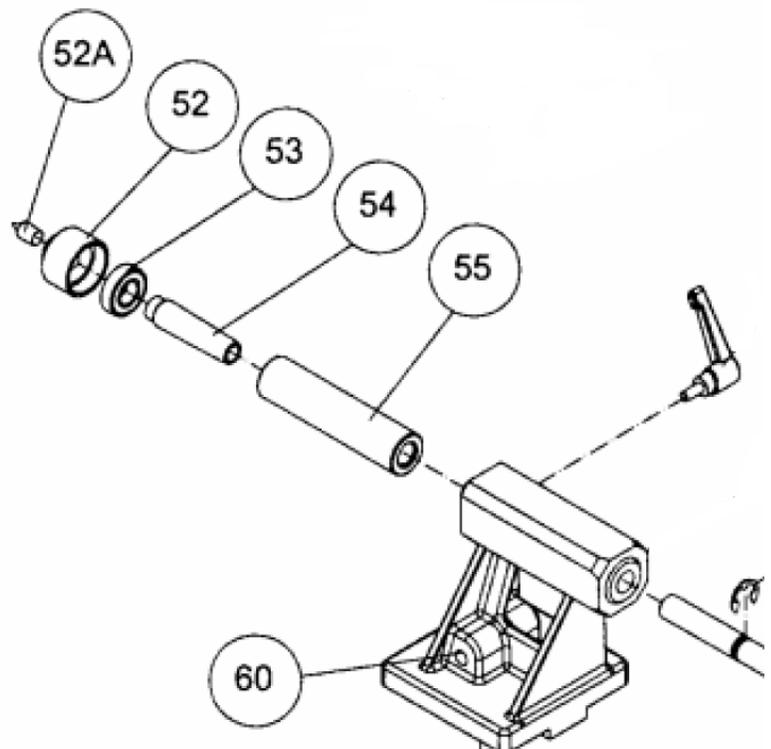
The exploded parts diagram from the Jet manual shows the parts of the live centre [52, 52A, 53 and 54]. An excerpt from the parts list is given below. You can see that the lathe manual gives the bearing [53]

part number	50	JML-50	Eccentric Locking Rod	1
as 6002ZZ,	51	JML-51	Bushing	1
so the	52	JML-52	Live Center Head	1
designer did	52A	JML-52A	Center Point for Live Center	1
his/her job.	53	BB-6002ZZ	Ball Bearing	6002ZZ 1
Production	54	JML-54	Live Center Shaft	1
messed it up!		708331	Live Center Assembly (not shown)	1
	55	JML-55	Tailstock Spindle	1

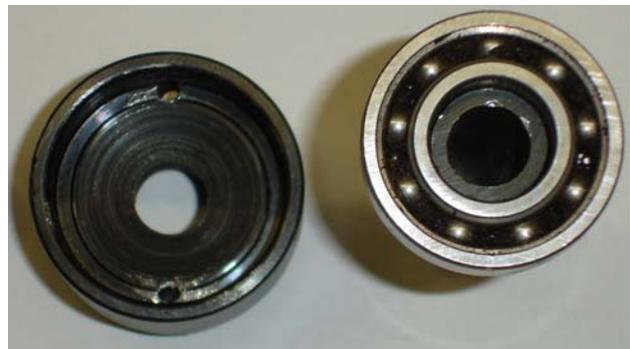
degrees apart. Then I used a pin punch to drift out the bearing. The picture shows a view from the rear of the head with the two holes drilled from the front. The unshielded side of the original bearing is shown, clogged up with a mixture of wood shavings and grease.

Replacement bearings are about R41- at Bearing Man. They don't even offer the single seal Z version, only the double seal ZZ version. To dismantle, the central shaft [54] was easily be tapped out from the inner race, as it was a light press fit. The outer race was more of a challenge, short of machining a special puller, it was not going to be extracted easily from the live centre head [52]. There are various tricks that can be used, such as heating up the bearing, and hoping differential expansion will loosen the fit. Or a bolt can also be welded to the inner race. I chose to drill two holes in the outer rotating centre from the side facing the

The holes needed to be tilted slightly, because of the geometry, and they were simply lined up by eye. The required tilt was achieved with a 2mm spacer on the side of hole being drilled, so that the drill went in at the correct angle. I knew when the drill had reached the outer race, as it simply stopped cutting. The material of the race is so much harder than the mild steel used for the centre, that the HSS drill made no visible impression on it all. 3.2 mm holes were drilled to accommodate a 3mm pin punch.

With bearing drifted out, it was a simple matter to press in a new one. If you are inexperienced in working with bearings, you must be careful to put no force on the rolling elements when you install the bearing. Any inadvertent shock loads can damage the balls or races, leading to premature failure. When you are removing a bearing that will not be reused, this is not important, but replacement requires some care. In this case, the inner shaft was pressed into place into the inner race using a metal working vise. The inner race was supported using a spacer to ensure that no force was being transmitted by the outer race. Then the outer race was pressed into place, using a tubular spacer, pressing only against the outer race, so no force was transmitted through the inner race. A socket spanner set is an excellent source of a range of hardened tubular spacers for this task. It is possible to drift the bearing into place, but care is needed to avoid any misalignment, or blows to the wrong part of the bearing. The bearing is supplied pre-lubricated.
