Crosscut

Newsletter of the Witwatersrand Woodworkers' Association
PO Box 411346, Craighall, 2024, South Africa

Small Table Saws

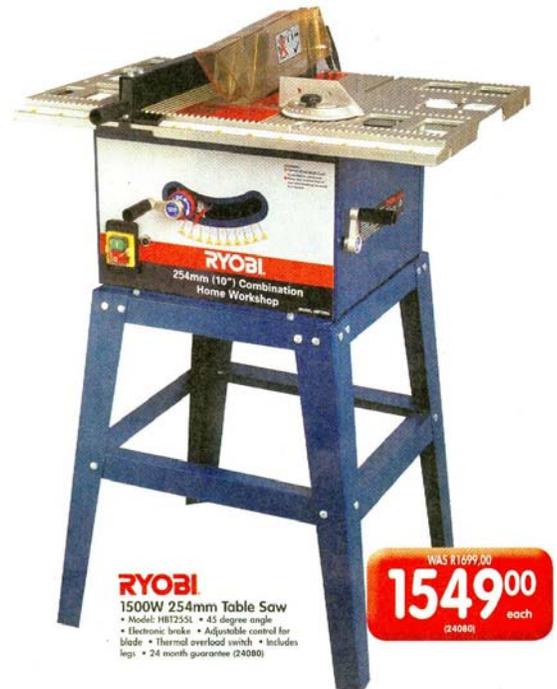
The small table saw I was given is a Ryobi HBT 250. It was somewhat neglected as it hadn't been used for about 5 years. The mechanism was stiff from rust, but it was basically sound. After some derusting and lubrication, the mechanism was restored to working order. A detailed inspection was made of the unit and a number of shortcomings were identified. This is a cheap saw, and it didn't have a good reputation for accuracy. It is still on the market (as model HBT255L) with a few small improvements and sells for about R1550- at Makro or Game – the picture shows the present unit on sale. (See right.)

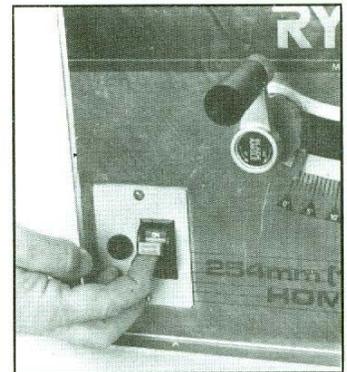
- **No No-Volt-Release (NVR) switch.** If you want to switch off in a hurry, there is likely to be some fumbling with the small toggle On-Off switch as shown in the picture on the right from the manual. Also, it is possible for the unit to be left switched on after a power failure, and when the power is restored, it can start up which can be dangerous. This could also occur when the unit is plugged in. You can see from the picture that the current model has an NVR switch and the specification states that there is a blade brake.
